MSD CRACK PROPAGATION BY DBEM ON A REPAIRED AERONAUTIC PANEL

R. Citarella

Fatigue flat riveted panel with skin repairs

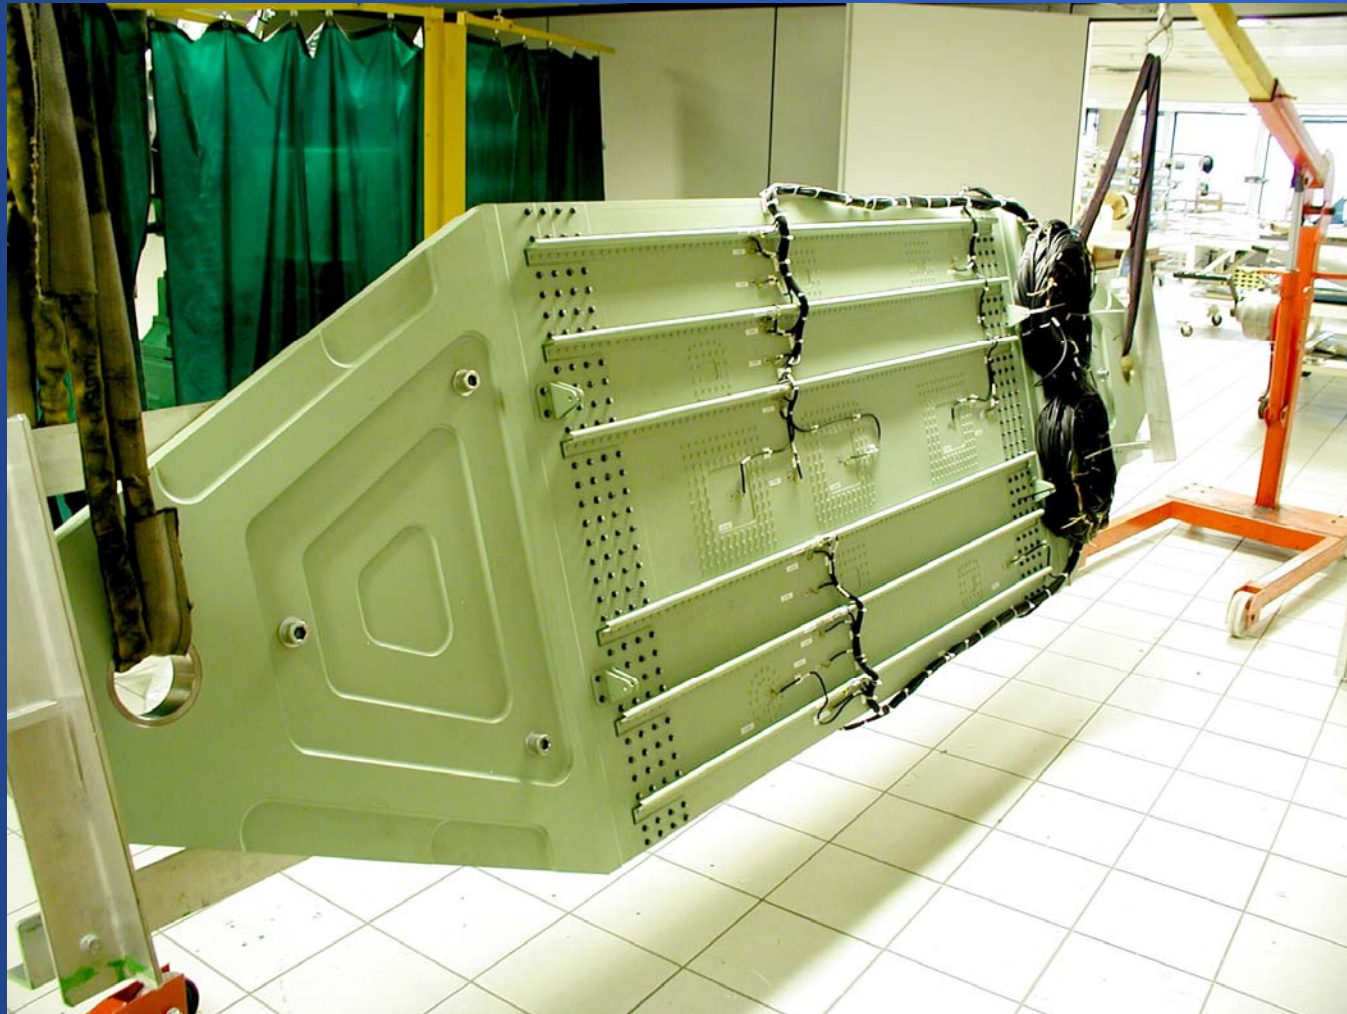
Panel in testing configuration: front view and backward view, with highlight of the repairs analysed: REP 3-5.

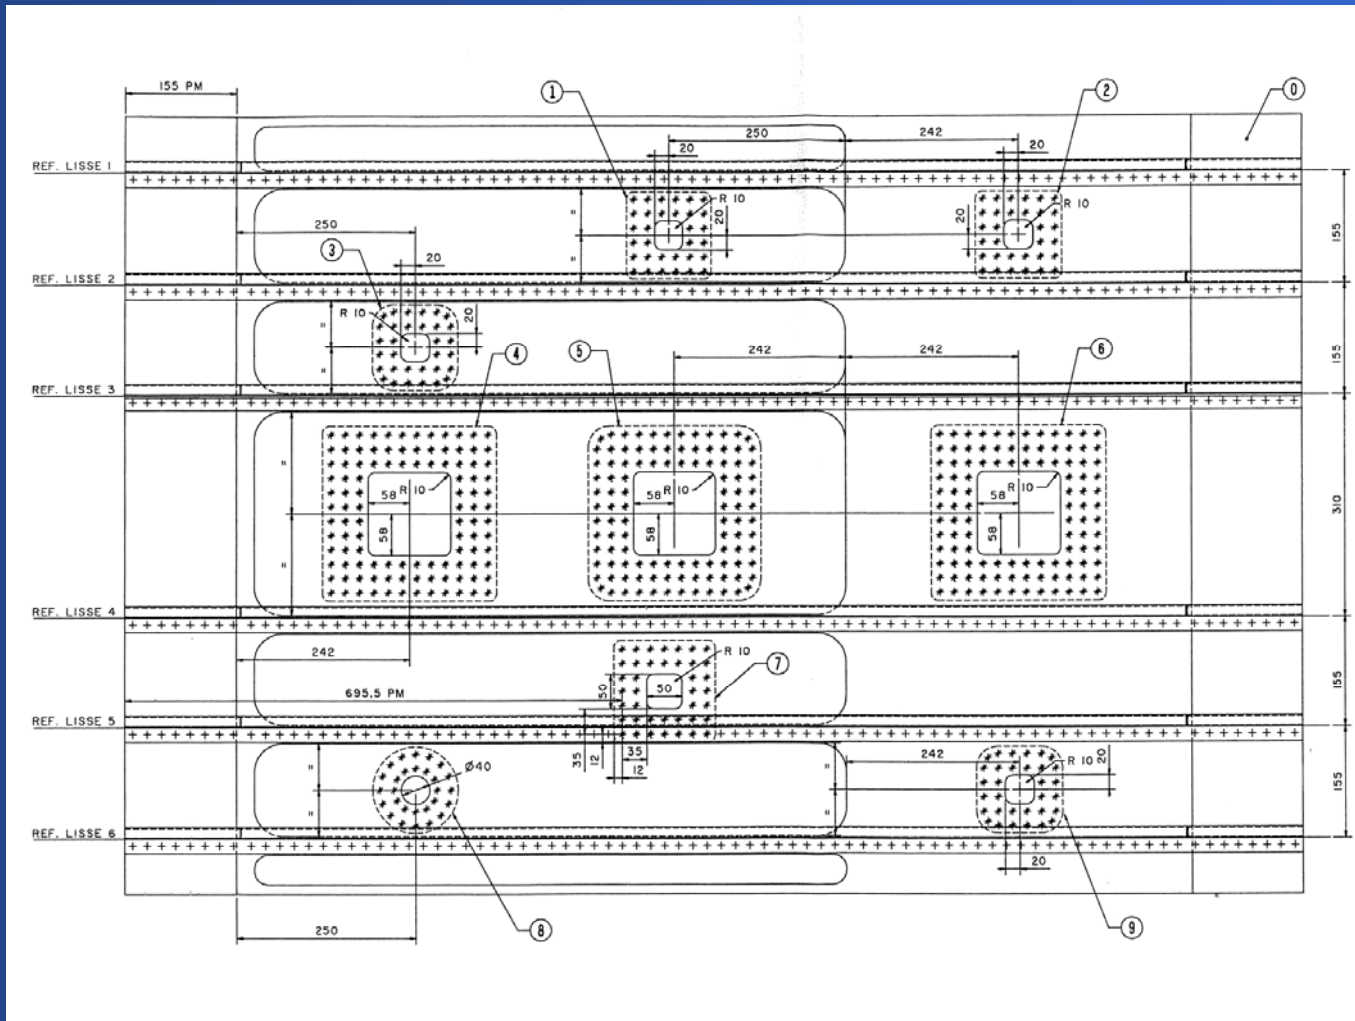
Drawing of the riveted repairs (N. 3, 4 and 5 are analyzed).

Repair	Skin thickness (mm)	Doubler thickness (mm)	Stiffener section (mm ²)	Ø rivets (mm)	Rivet transversal stiffness (K_x, K_y) in N/mm
REP 3	1.65	1.8	99	4.0	2.9E+4
REP 4	1.65	1.8	99	4.0	2.9E+4
REP 5	1.65	1.8	99	4.0	2.9E+4

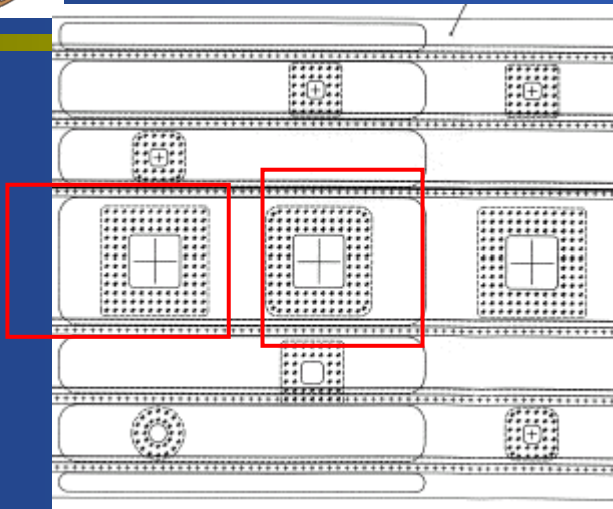
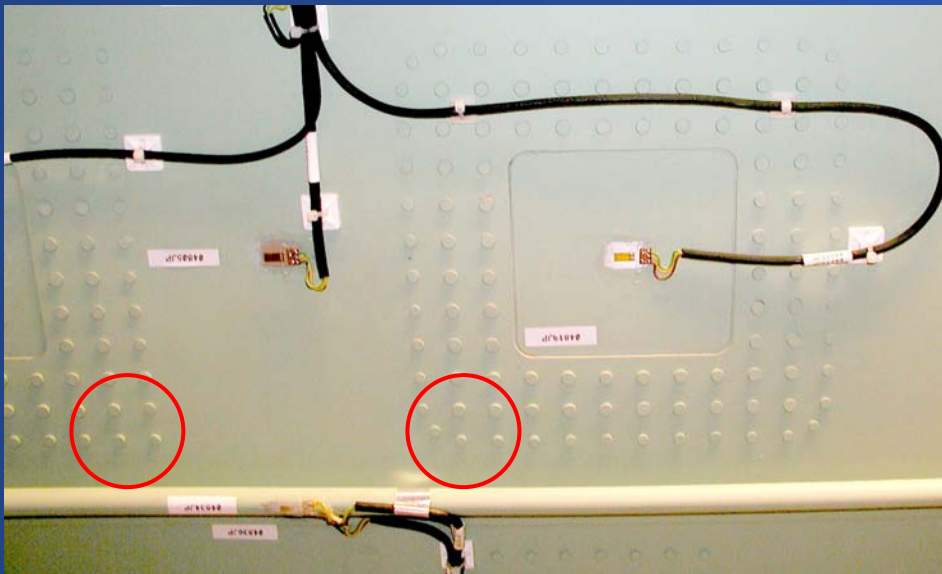
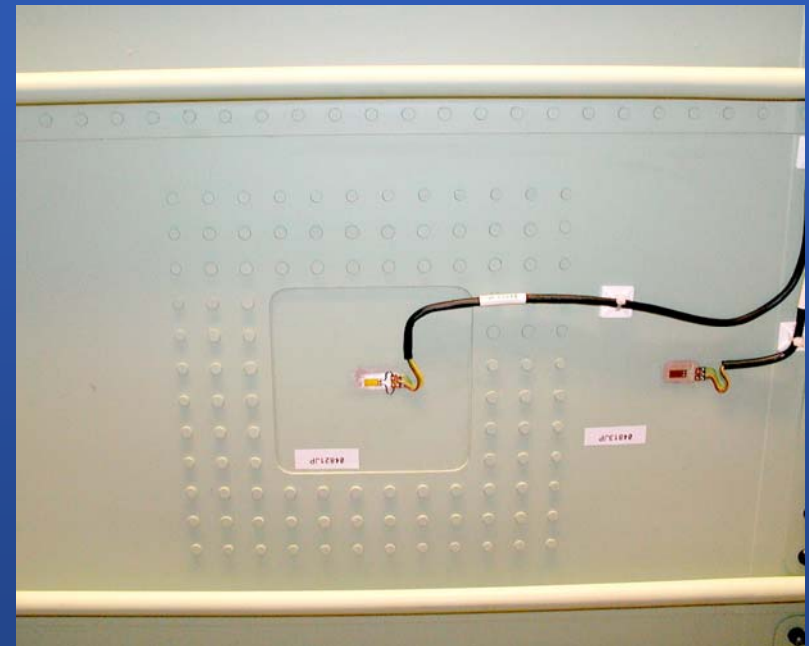
Standard & improved fastener location

Standard 3 rivet rows skin repair

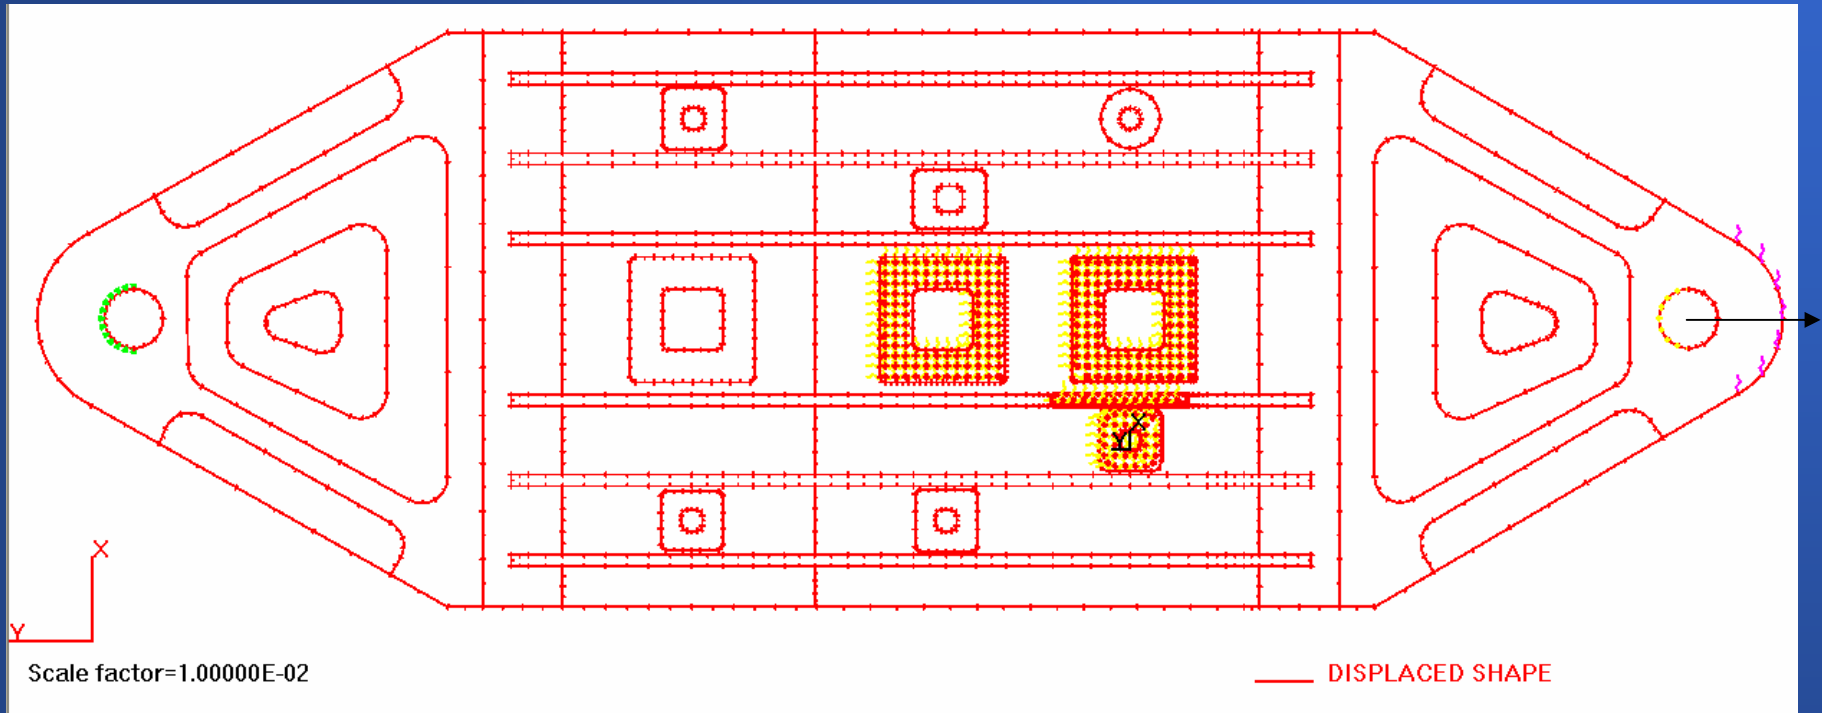
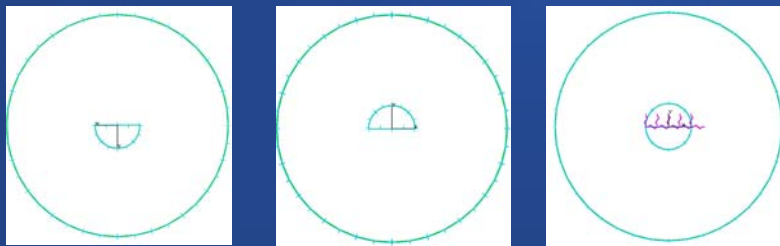
DBEM model of the repaired panel with highlight of analysed repairs, mesh and boundary conditions.

Rivet halves respectively engaged with the skin (left) and with the doubler (centre) to form the assembled rivet (right). The two halves are connected each other by “internal springs” (right).

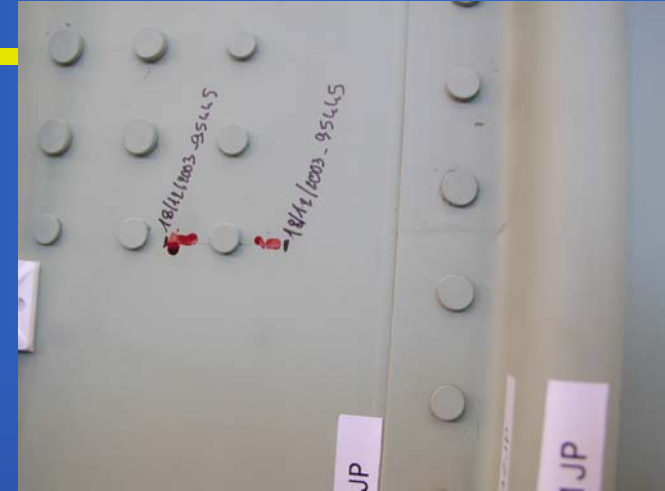
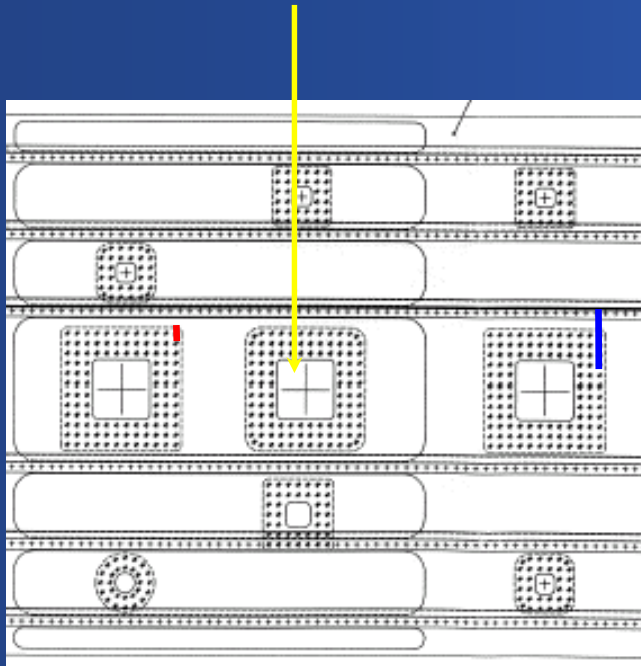
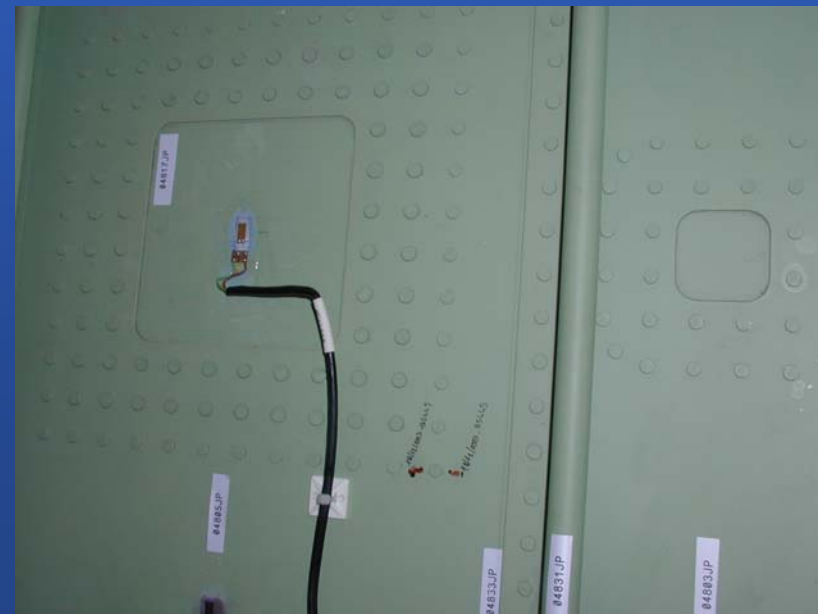
REP 4 : standard 3 rivet rows repair

- ❑ 25 mm crack starting from the fastener located in the corner
- ❑ Fatigue life lower than similar improved 3 repair REP5 → good point

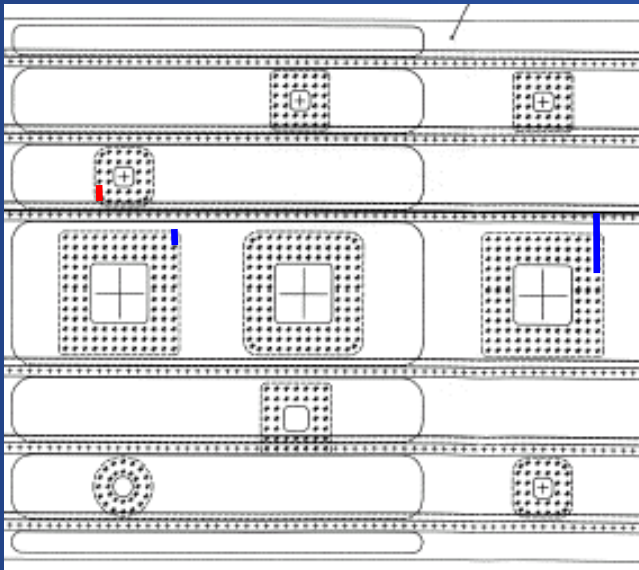
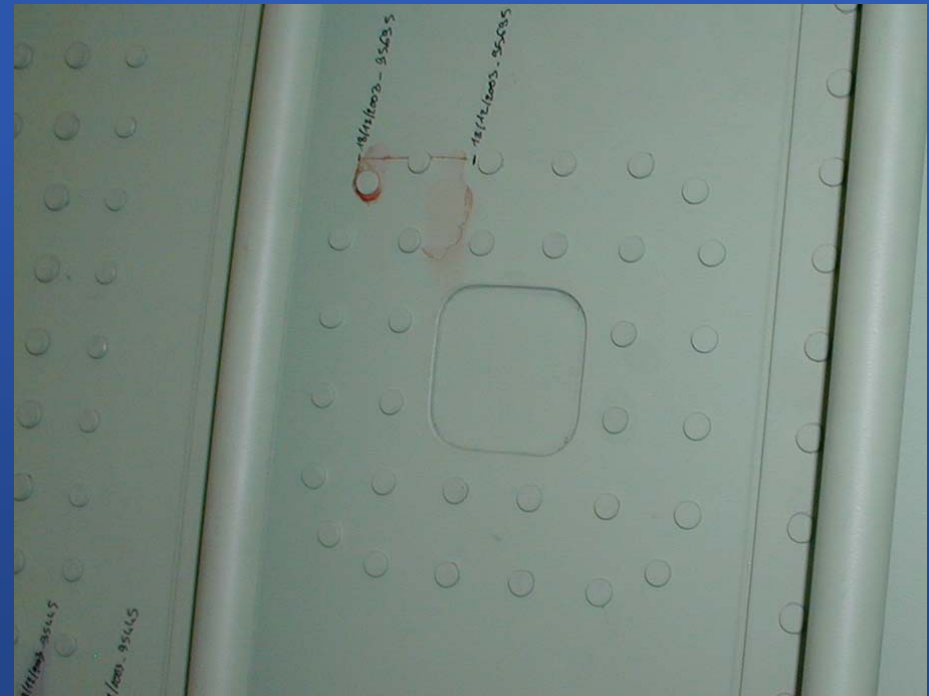
✓ At 95695 FC (250 cycles later), 1 other repair cracked :

- REP 5 : Improved 2 rivet rows repair
 - ❑ 33.5 mm crack which initiated at critical fastener
 - ❑ Fatigue life lower than the similar standard 2 fastener rows repair REP 1
 - ➔ bad point.

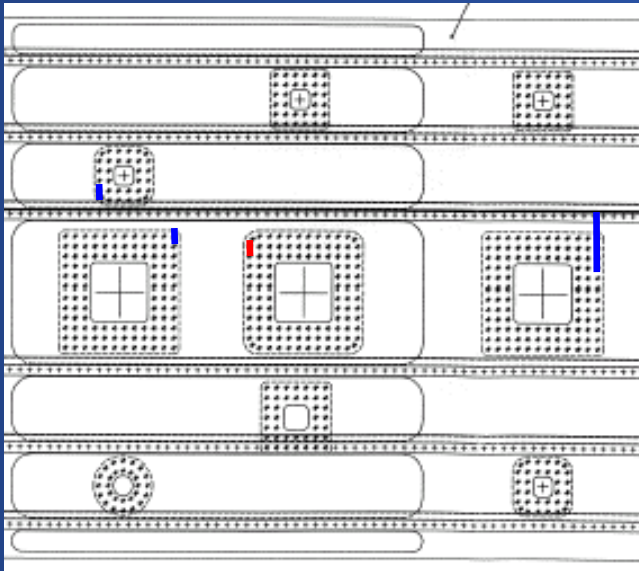
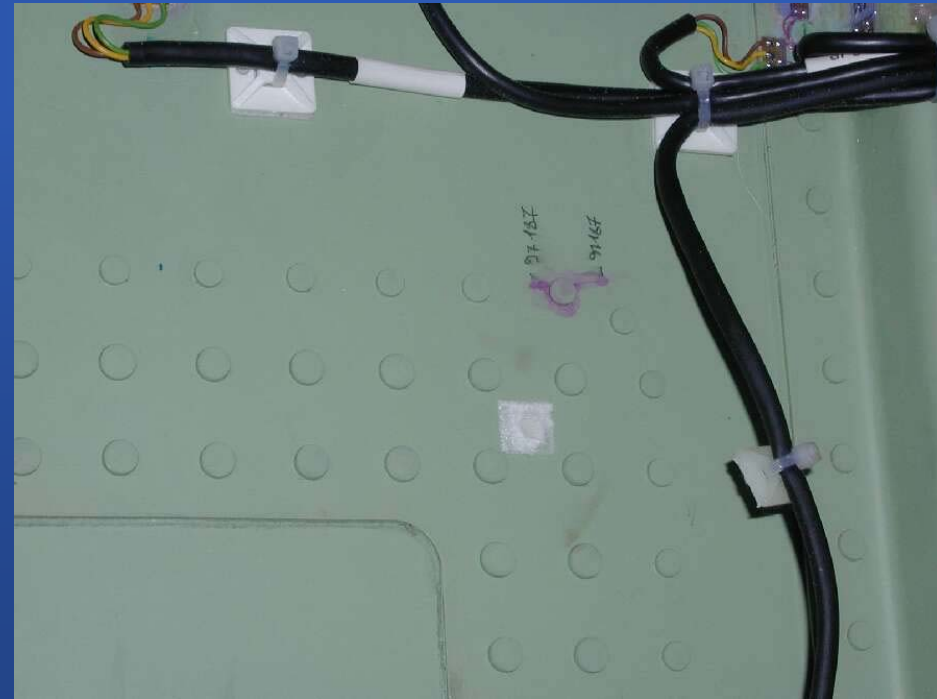
✓ At 97187 FC, REP6 :

- REP 6 : Improved 3 rivet rows repair
 - 17 mm crack which initiated at critical fastener

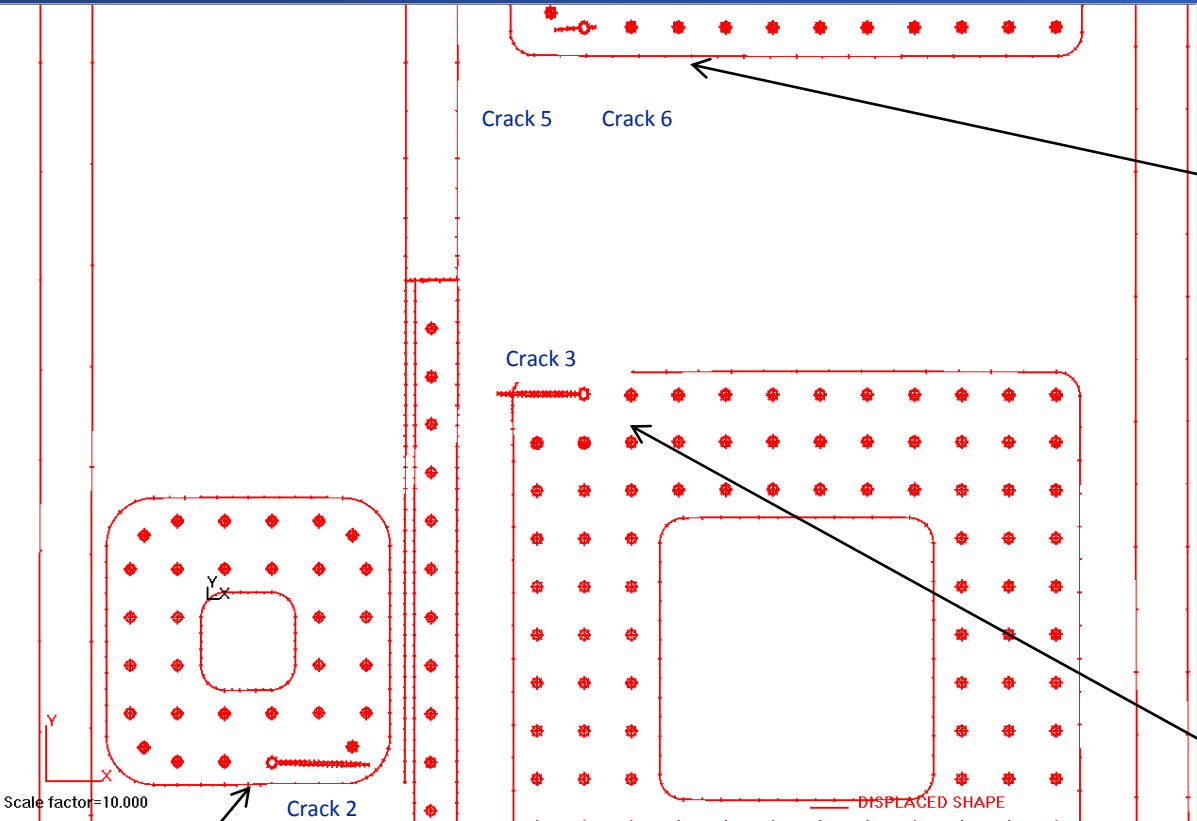
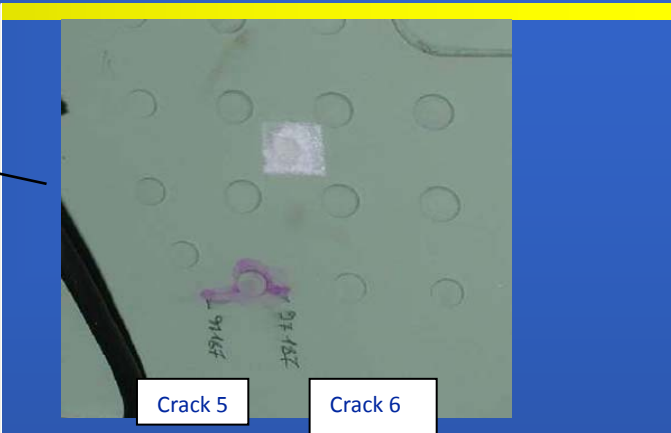
Cycle range: 97900-103465

Deformed plot (scale factor 10) of the initial crack scenario at 103465 cycles, involving repairs REP 3, REP 4 and REP 5 with, respectively, crack 1-2, crack 3-4 and cracks 5-6 (cracks 1 and 4 have, at this stage, just been detected in the experimental test).

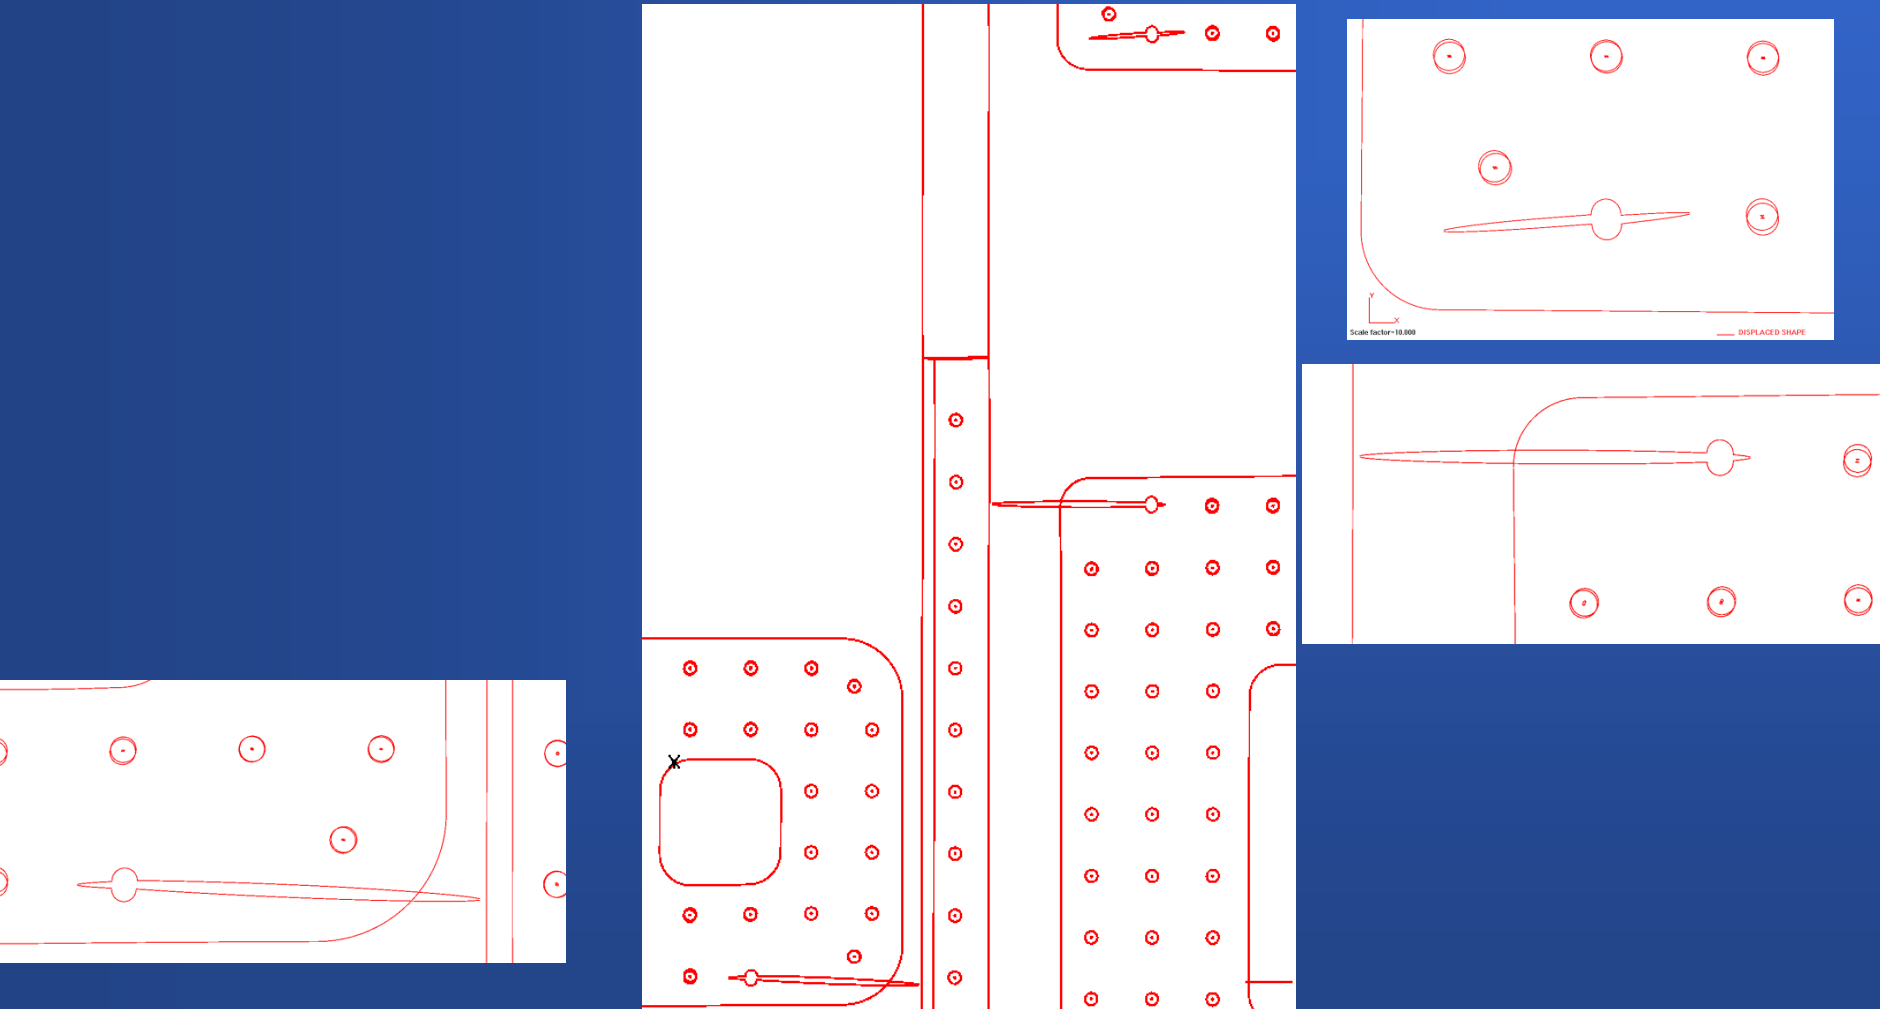
Cycle range: 103465-104620

Von Mises stresses (MPa) on the skin deformed plot (scale factor 15), showing the crack scenario at 104620 cycles, with highlight of the stress state on the remaining ligament between crack N. 2 and the adjacent hole: here the ligament is fully plastic with consequent link-up

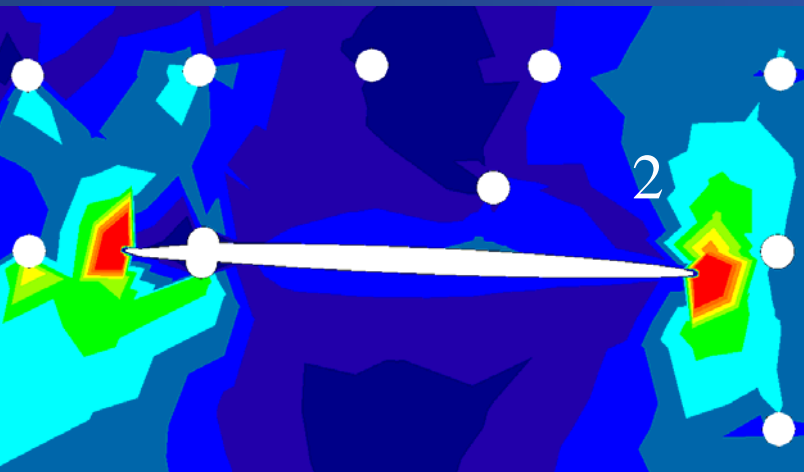
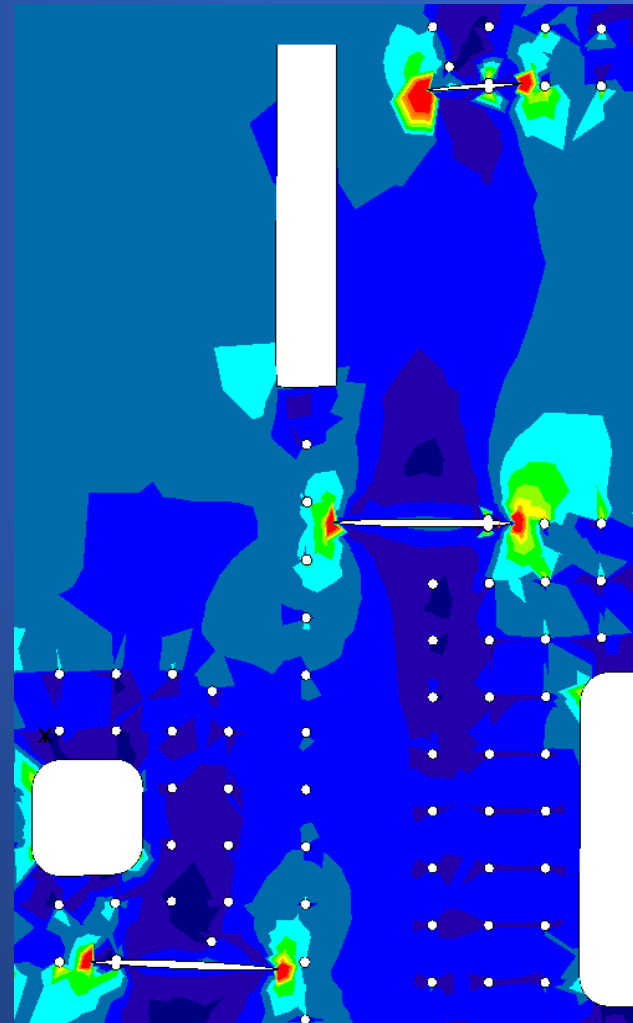
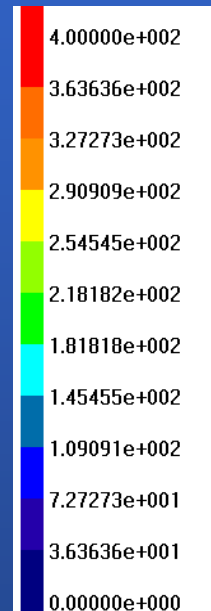
Deformed plot of the initial crack scenario at 104620 cycles, with highlight of the modeled link-up between the crack N. 2 and the adjacent hole (the crack is replaced by a slot).

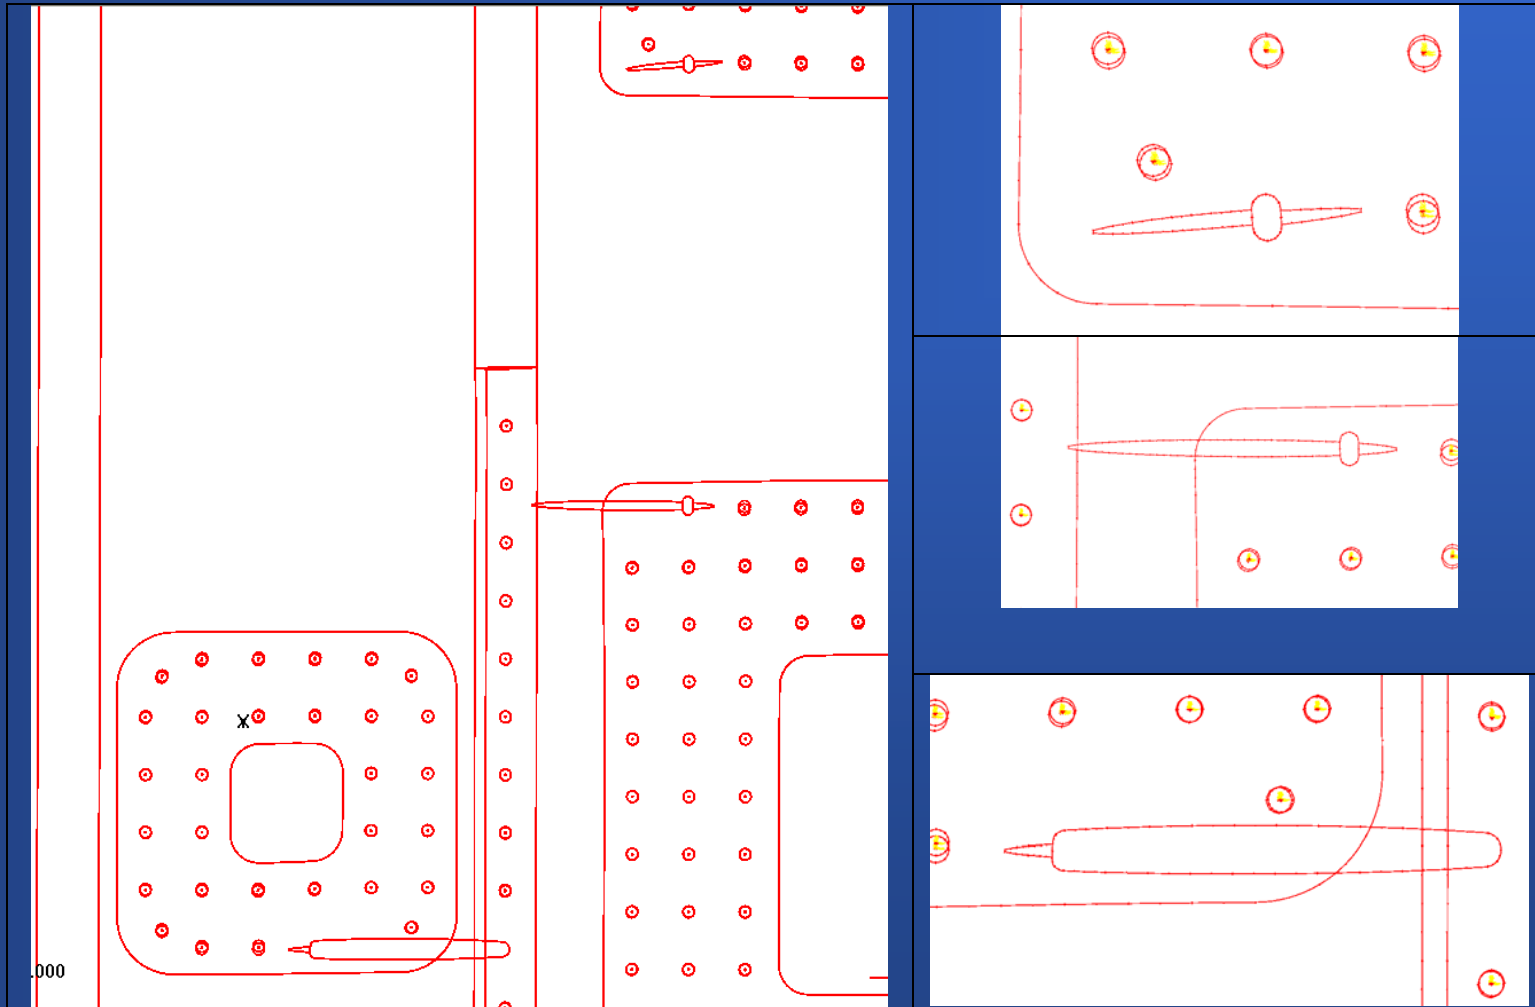
Cycle range: 104620-104897

Von Mises stresses (MPa) on the skin deformed plot (scale factor 15), showing the crack scenario at 104897 cycles, with highlight of the stress state on the remaining ligament between crack N°1 and the adjacent hole: the ligament is mostly plastic with consequent link-up

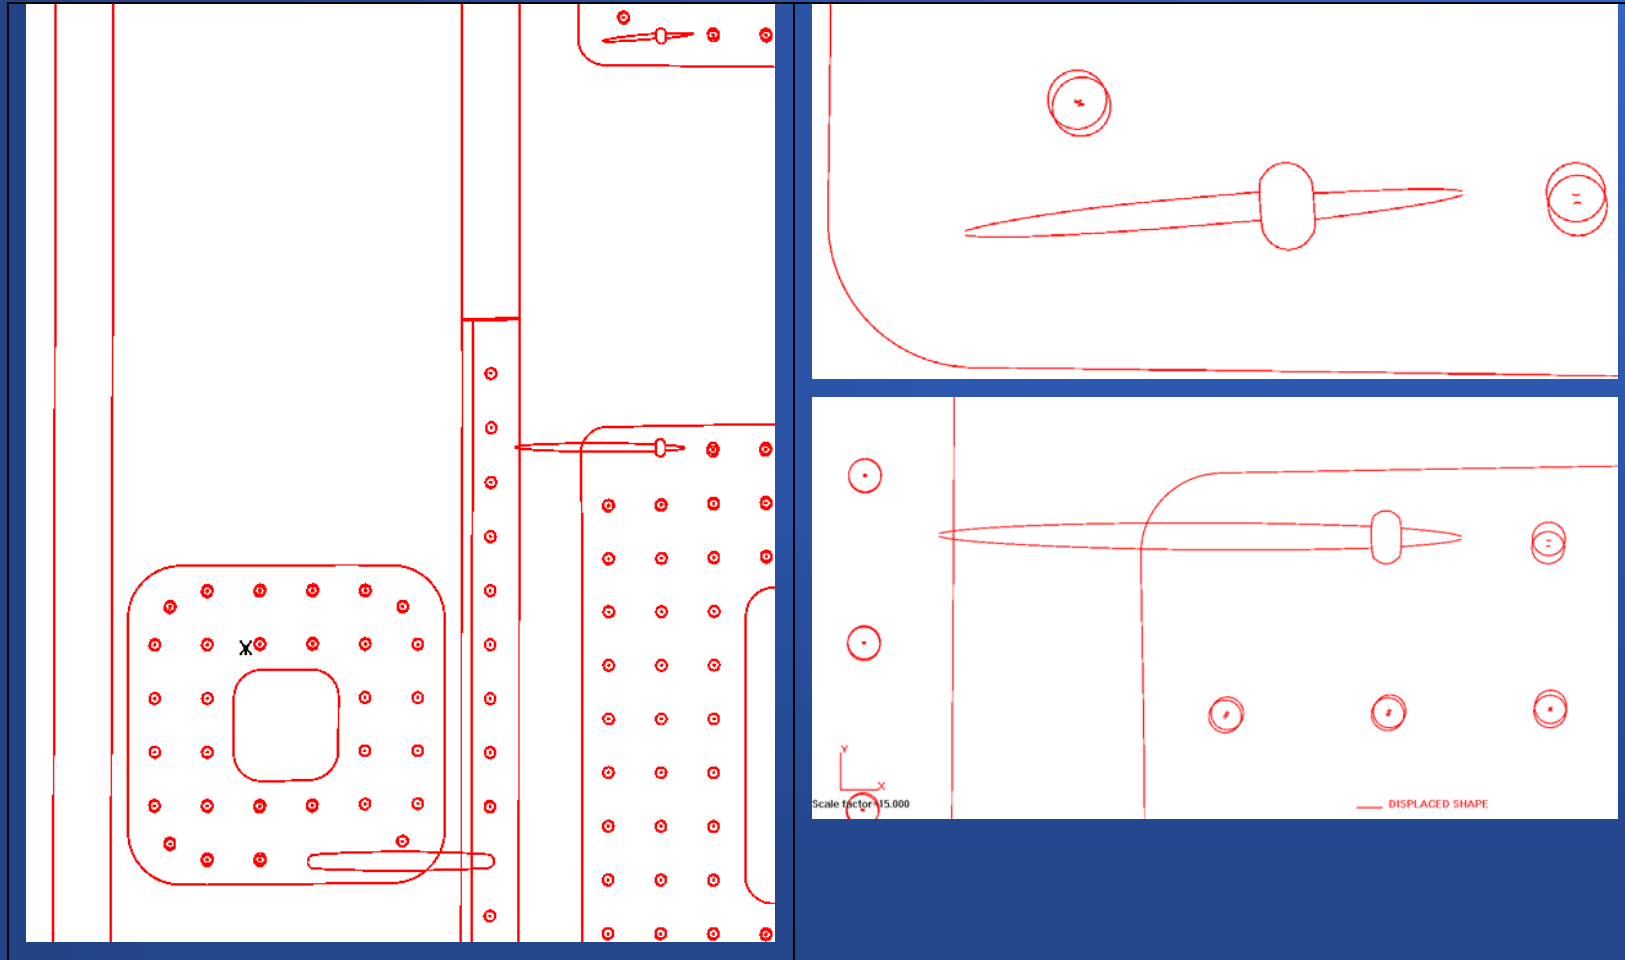
Von Mises stresses (MPa) on the skin deformed plot (scale factor 15), showing the crack scenario at 105937 cycles, with highlight of the stress state on the remaining ligament between crack N. 4 and the adjacent hole: the ligament is fully plastic with consequent link-up

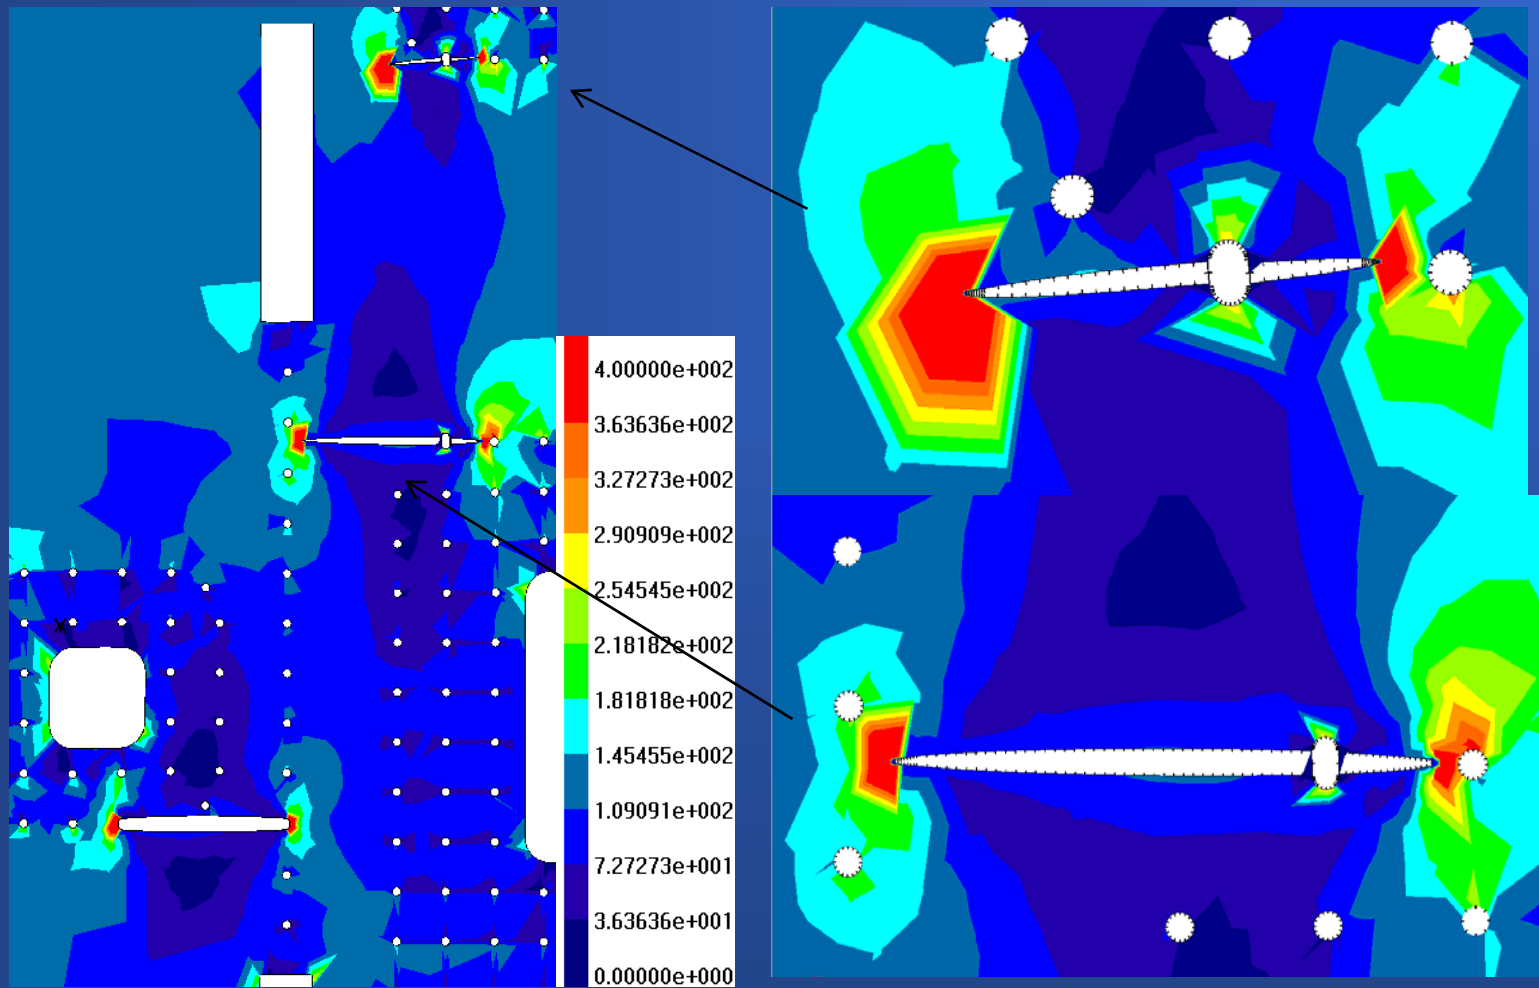
Cycle range: 105937-106793

Deformed plot (scale factor 15) of the initial crack scenario at 105937 cycles, with highlight of the link-up between the crack N. 4 and the adjacent hole (middle-right), and of the new initiation of crack 1 (down-right).

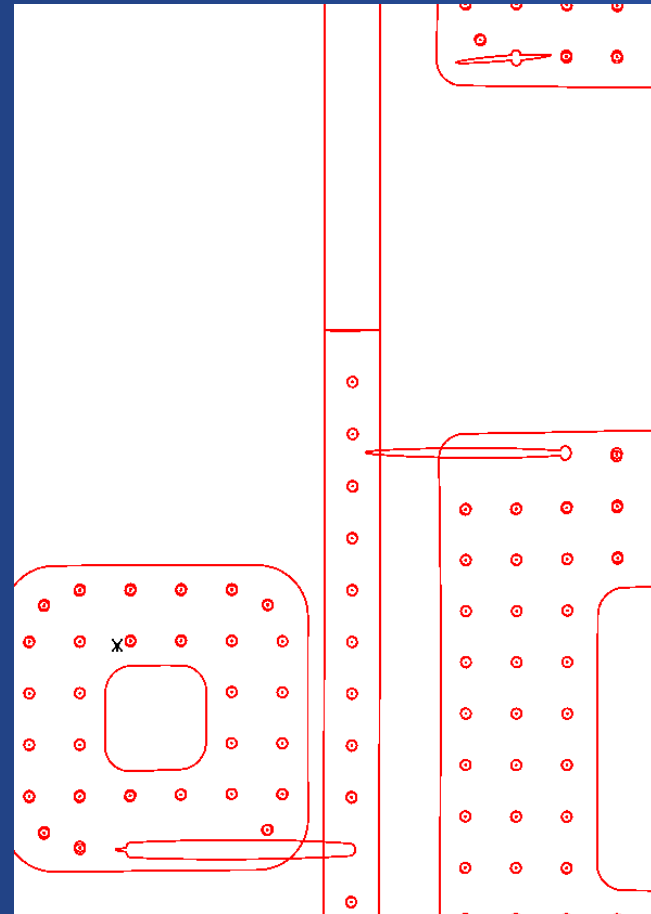
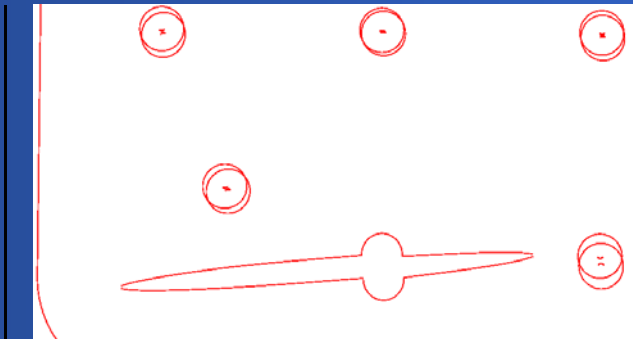
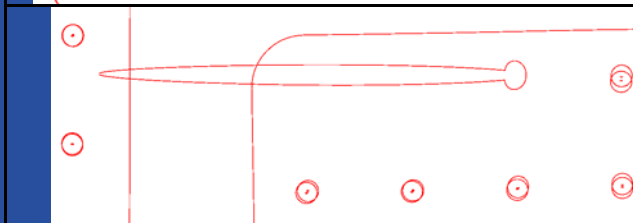
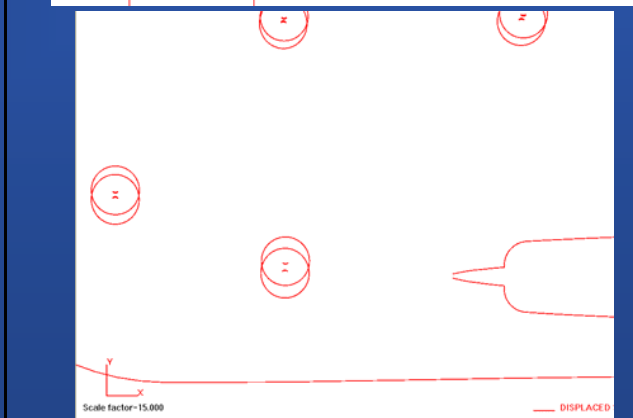
Von Mises stresses (MPa) on the skin deformed plot (scale factor 15), showing the crack scenario at 106793 cycles, with highlight of the stress state on the remaining ligament between crack N. 1 and 6 and the respective adjacent holes: the ligament is mostly (crack N. 1) or fully (crack N. 6) plastic with consequent link-up.

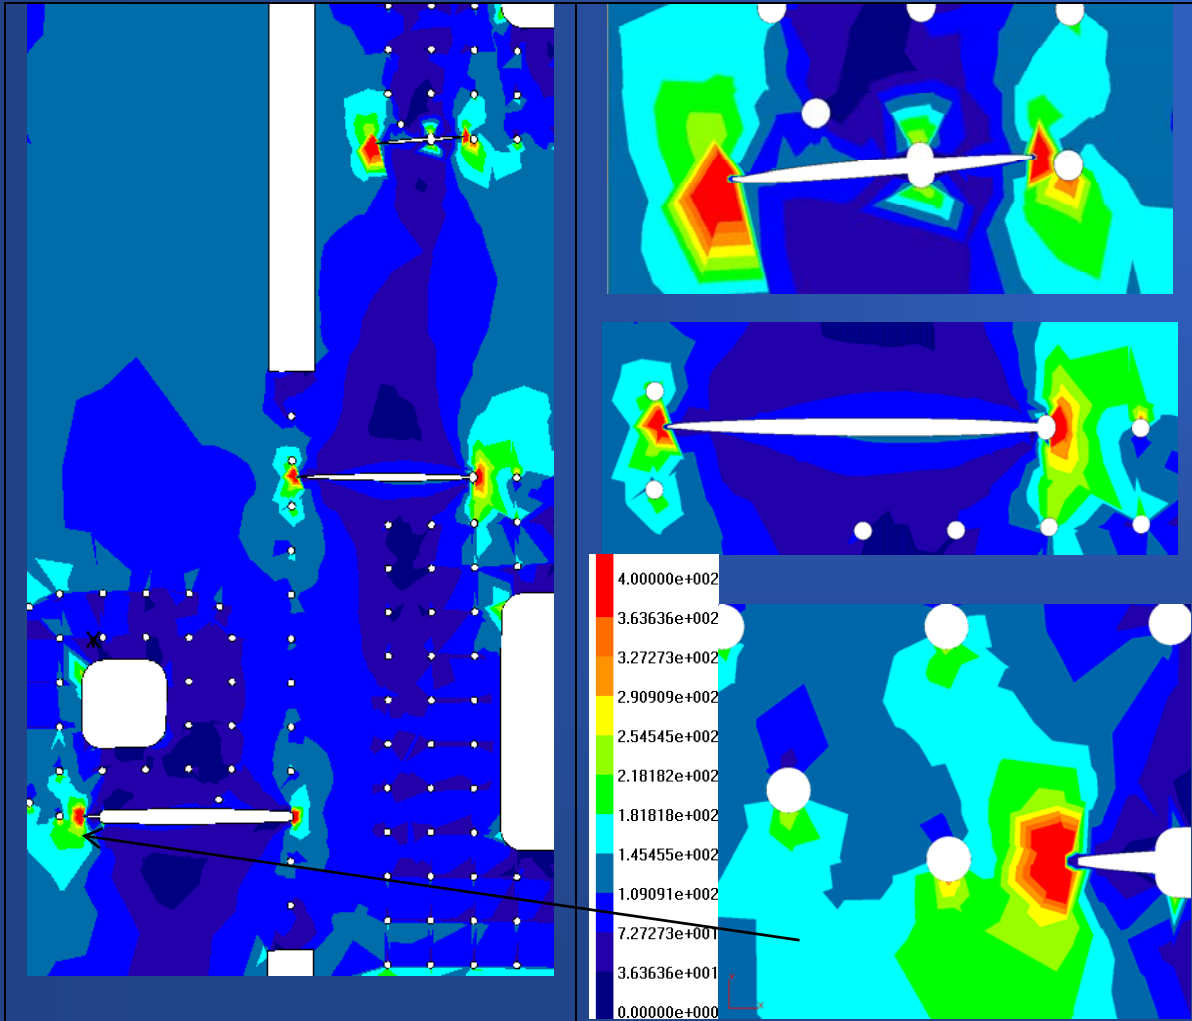
Cycle range: 106793-107831

Deformed plot (scale factor 15) of the initial crack scenario at 106793 cycles, with highlight of: the link-up between the crack N. 1 and the adjacent hole (down-right) with immediate new initiation; the link-up of crack 6, that, on the contrary, is arrested by the adjacent hole (up-right); the numerical vs. experimental scenario of cracks N. 5 and 6 (middle-right).

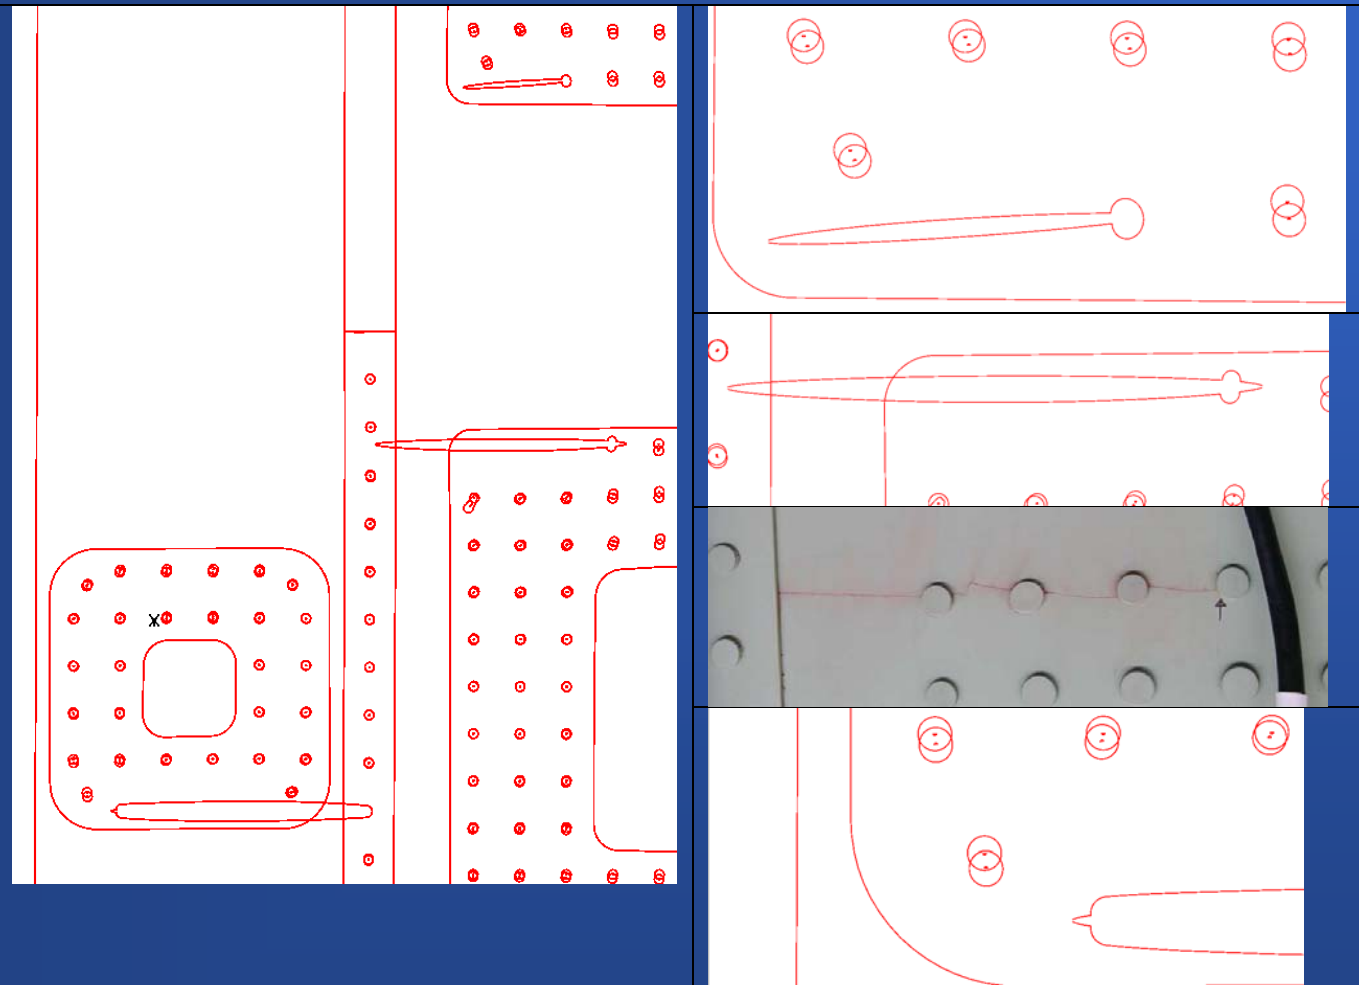
Von Mises stresses (MPa) on the skin deformed plot (scale factor 15), showing the crack scenario at 107831 cycles, with highlight of the stress state on the remaining ligament between crack 1 and 4 and the respective adjacent holes: the ligaments are fully plastic with consequent link-up.

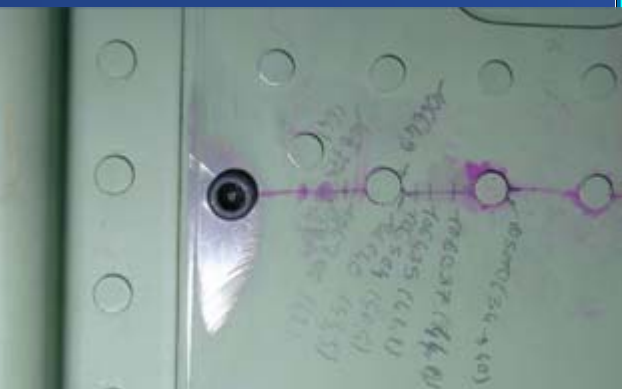
Temporary repair to arrest the propagation of crack N. 1
