MSD CRACK PROPAGATION BY DBEM ON A REPAIRED AERONAUTIC PANEL

R. Citarella

Fatigue flat riveted panel with skin repairs

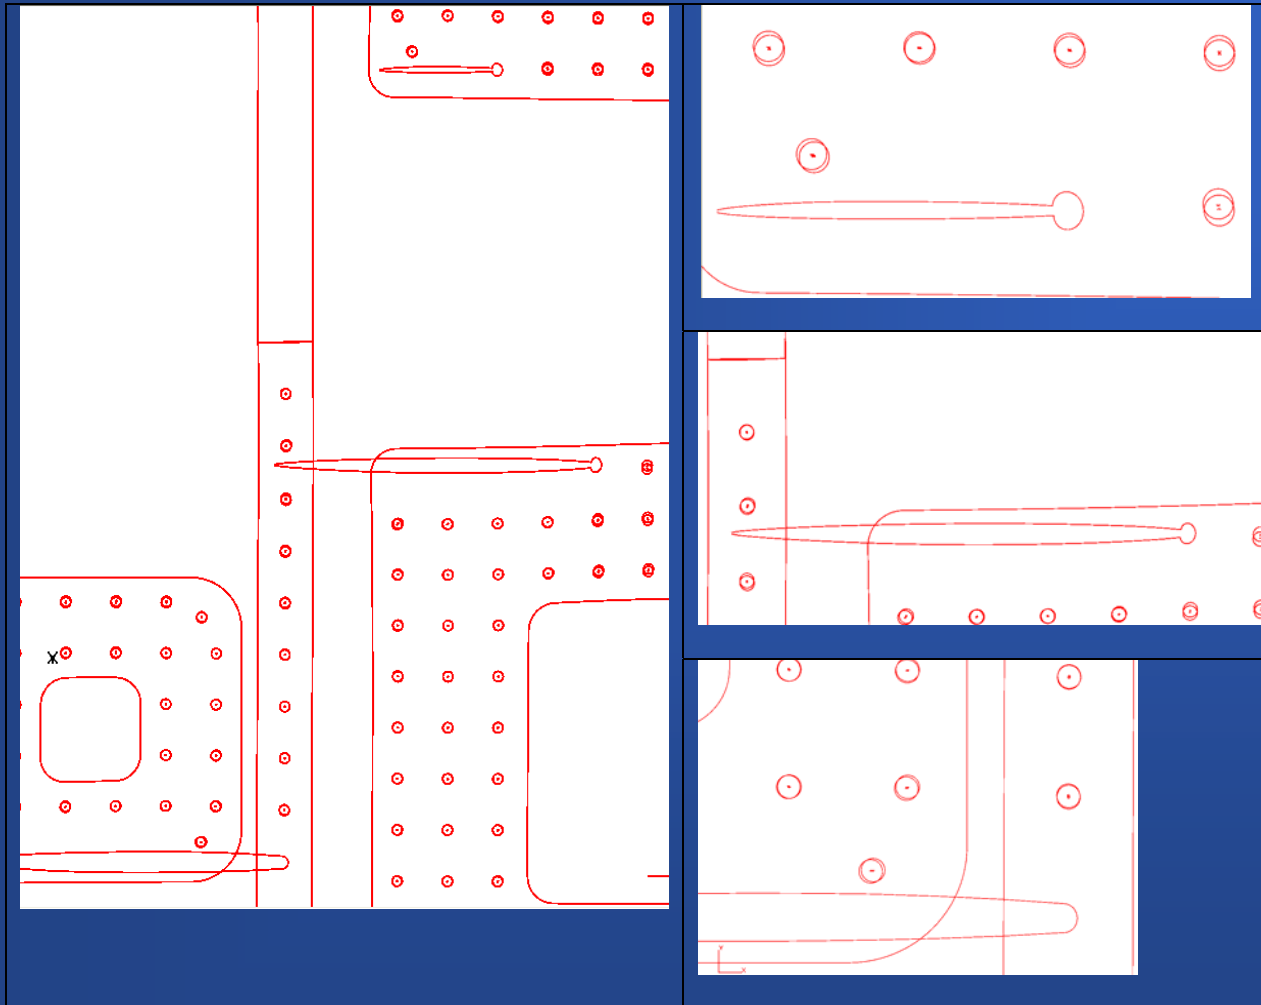
Cycle range: 107831-109200

Deformed plot (scale factor 15) of the initial crack scenario at 107831 cycles, with highlight of the modeled link-up between the crack 4 and the adjacent hole (middle-right).

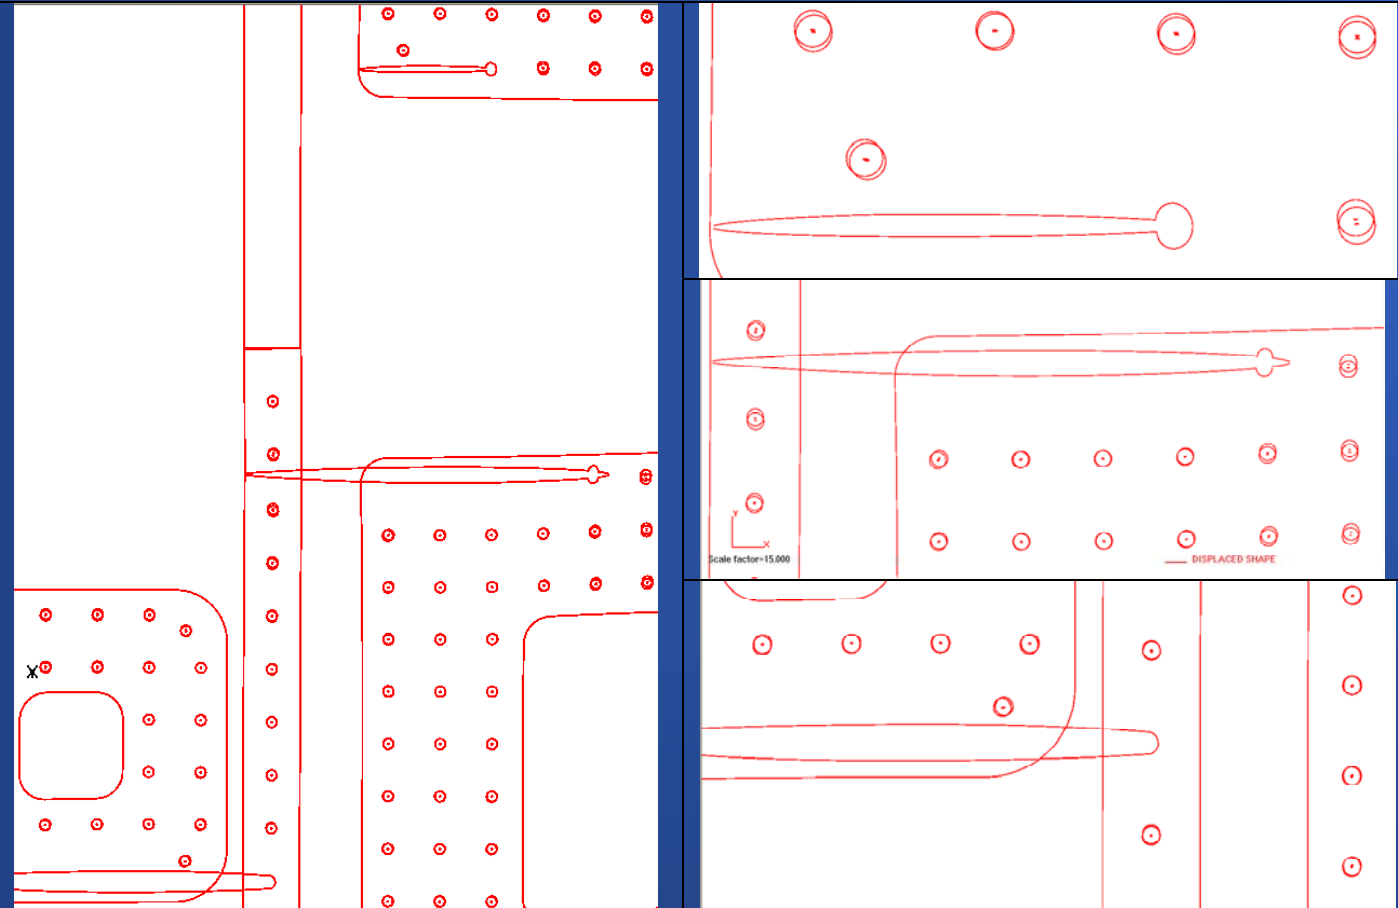
Cycle range: 109200-110000

Deformed plot (scale factor 15) of the initial crack scenario at 109200 cycles, with highlight of the modeled new initiation of crack N. 4 (middle-right).

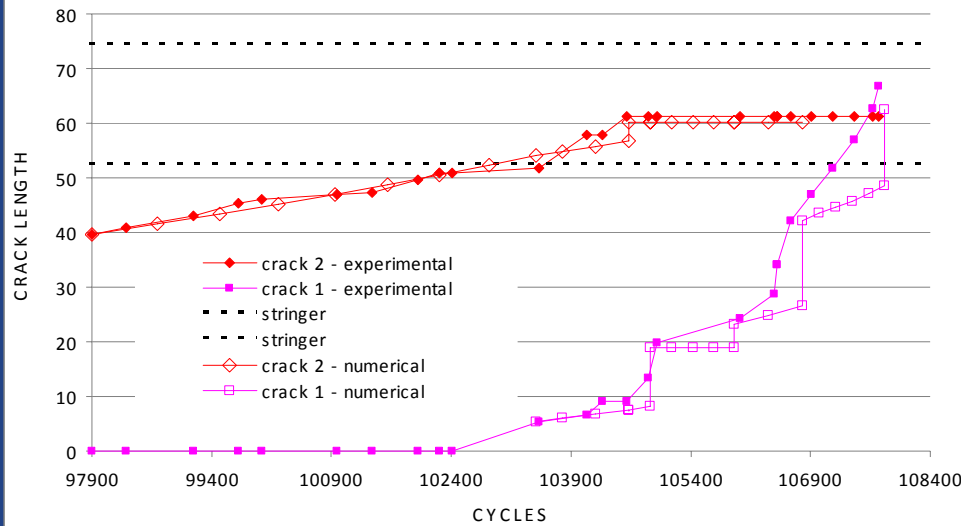
CRACKS ON REPAIR 3

Numerical-experimental comparison

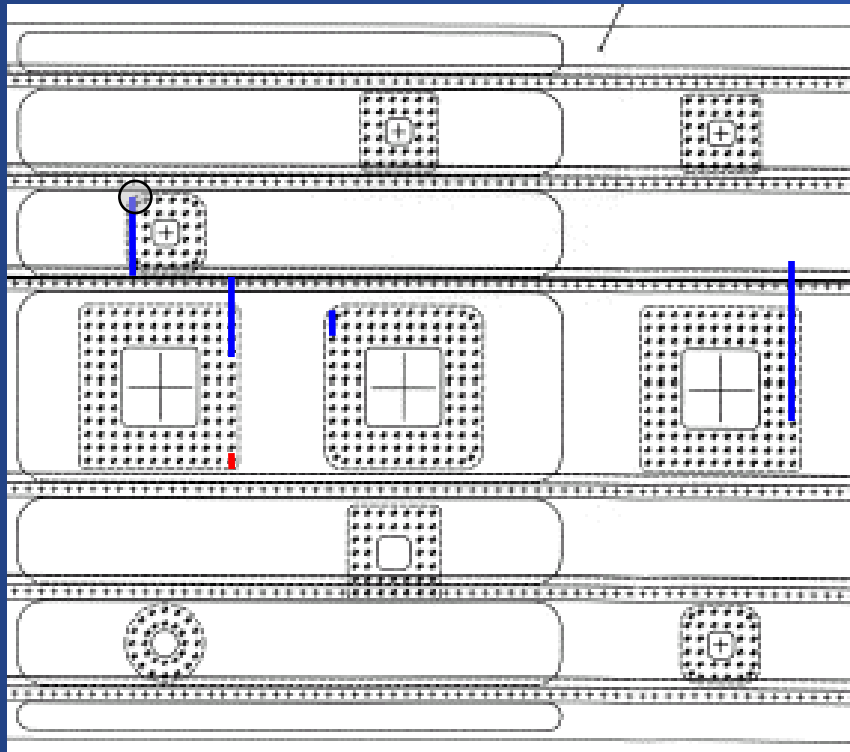
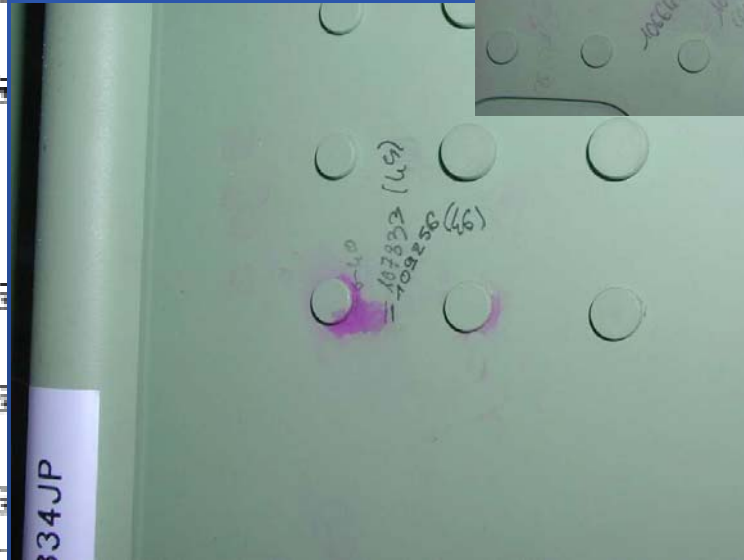
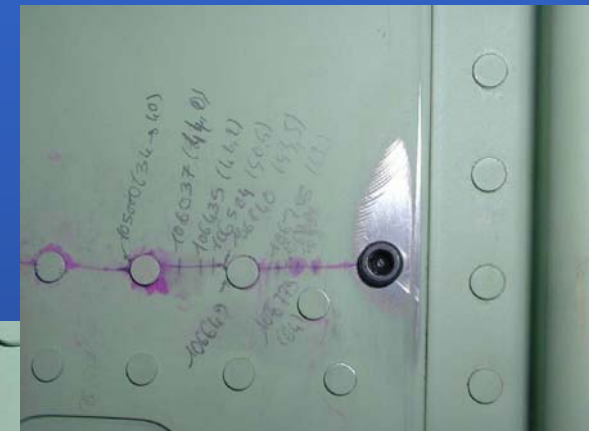
✓ At 107 833 FC, :

- REP 2 : Standard 3 rivet rows repair : 2nd crack initiates (5 mm)
- REP 5 : the whole 1st row cracked → temporary repair
- REP 6 : slow crack growth compared to REP 2

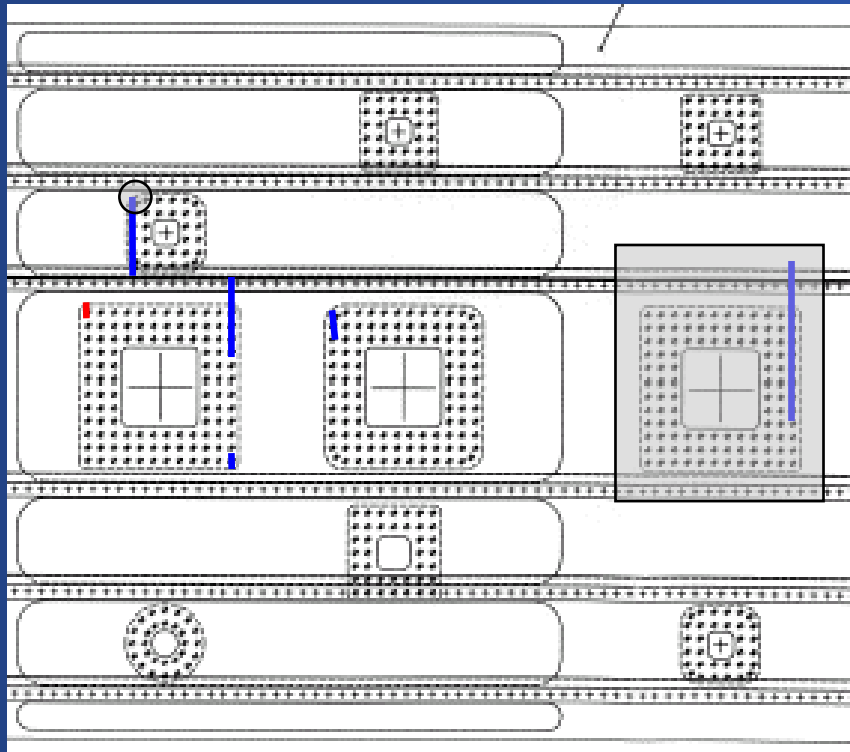
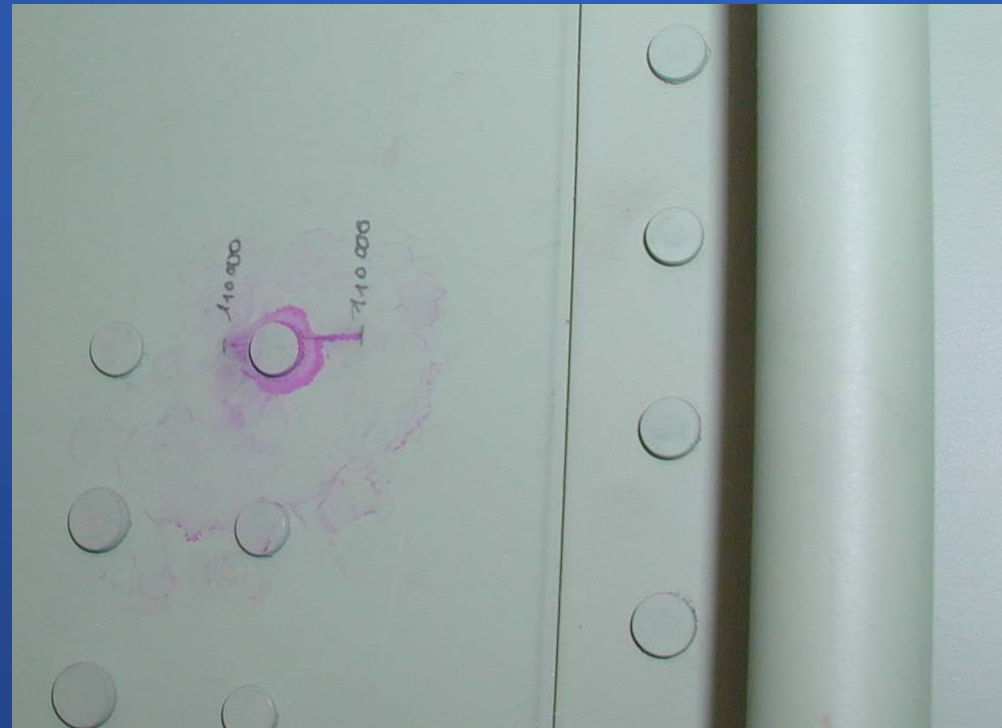
✓ At 110 000 FC, :

- REP 2 : Standard 3 rivet rows repair : 3rd crack initiates (15 mm)
- REP 4 : debonding
 - suppress doubler → rebond a full doubler (@109256)

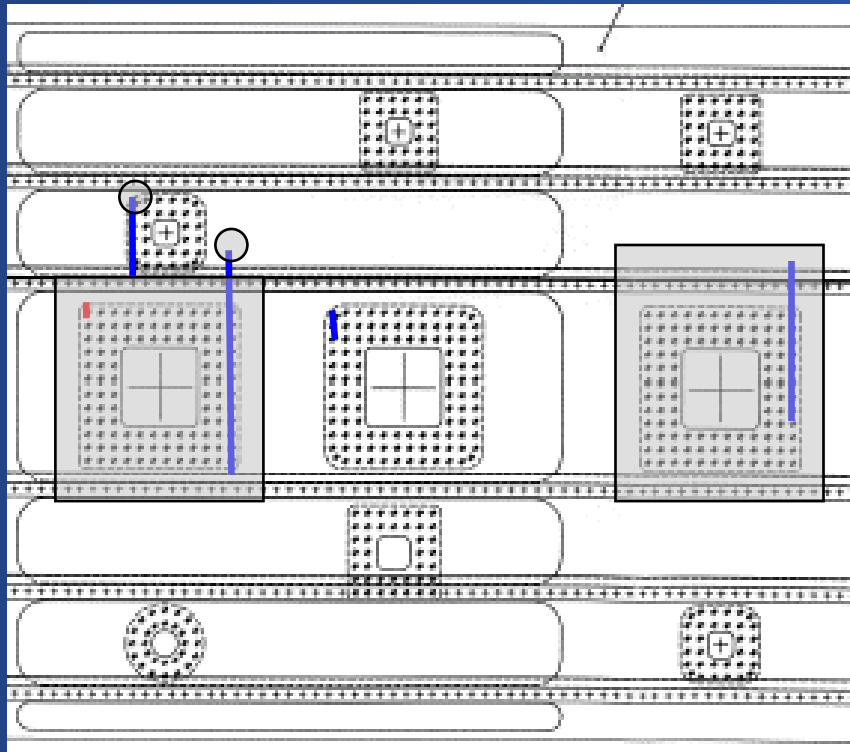
- ✓ Today status : 112 104 FC simulated. No other crack initiates
- ✓ REP 2 high speed (350 mm crack) → suppress doubler + rebond a full doubler + temporary repair (to study REP5)
